Job No. **22-10-42365**
Report No. **R-14042**

Lot 11 Rise Avenue

WOODFORD QLD 4514

Geotechnical Investigation

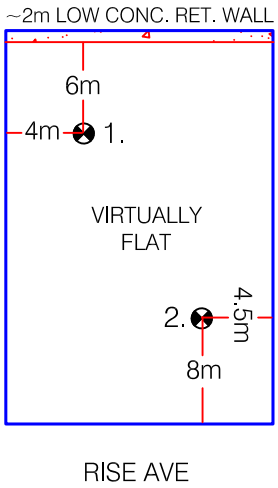
SITE SKETCH

⊗ TEST SITES ——► SLOPE DIRECTION
